- Tree Inventory and Risk Assessment -

CENTRALIA PARKS AND STREET TREES

Prepared by: Washington Forestry Consultants, Inc.

Date of Report: February 28, 2020

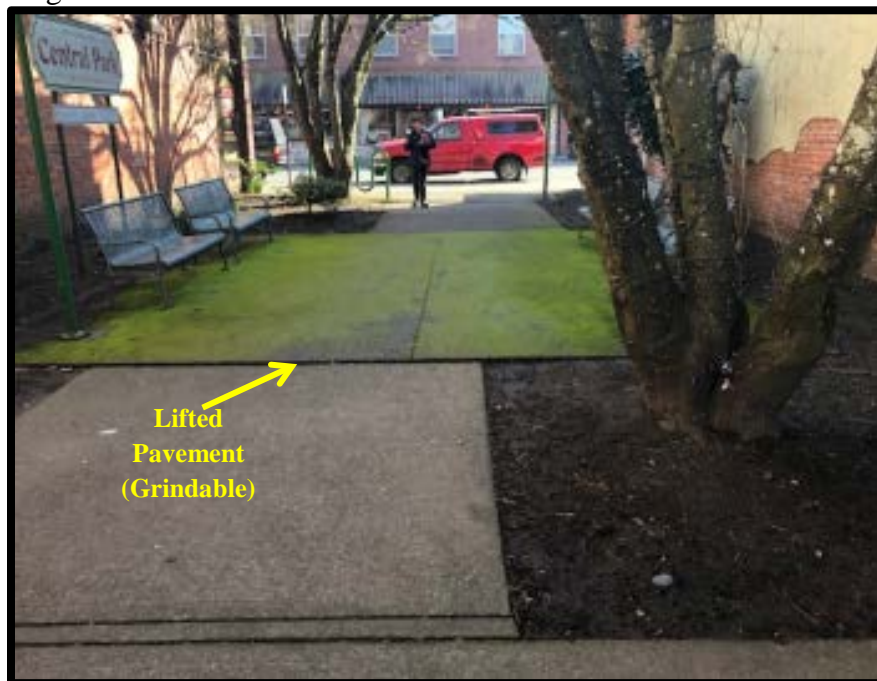
Norway maple is the most abundant tree species planted in the downtown core area. This tree species is highly tolerant of urban conditions such as poor soil and air pollution, but its root system is aggressive and usually grows near the soils surface, which can conflict with urban hardscape such as tree grates, sidewalks, other hard surfaces, and curbs. Most of the Norway maple trees and some of the oak trees in Centralia’s downtown core are relatively young and have yet to cause significant damage to the hardscape. The few instances of root-on-hardscape conflict can be resolved either by grinding exposed edges or by removing soil from tree grates and lowering the grates.

Photo 1. Lifted concrete slabs in the Central Park area of downtown Centralia. View looking east.

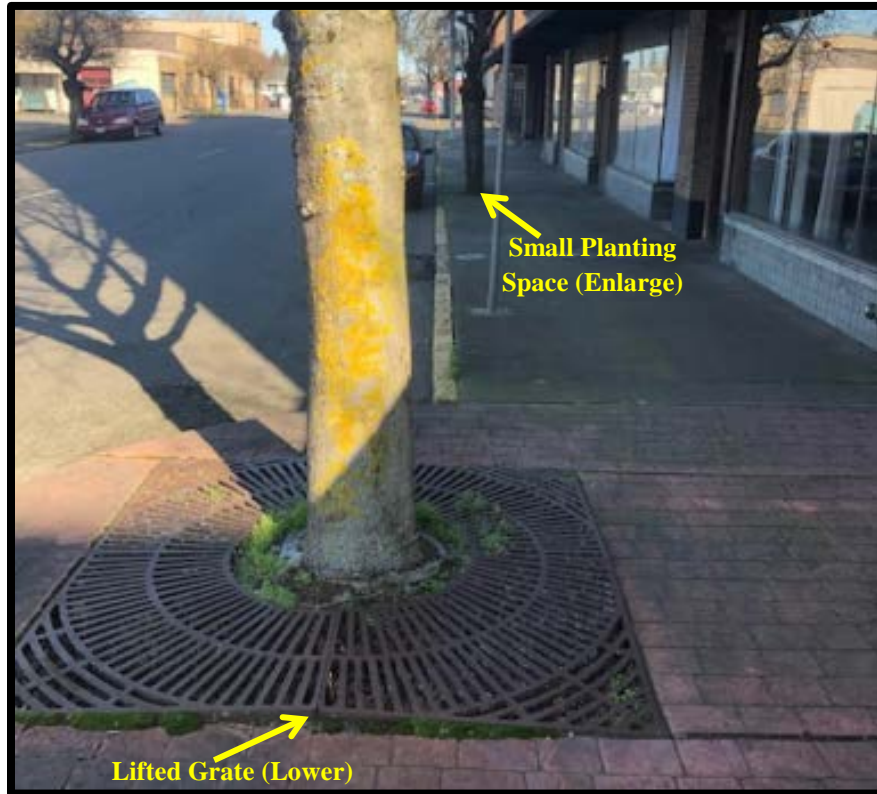
Most of the flowering cherry trees in the downtown area are surrounded by concrete with little soil surface. Often, the tree well is only slightly larger than the stem of the tree. If the health and vigor of these trees is to be sustained, and conflicts with the pavement avoided minimized, then enlargement of the tree wells is necessary.

Photo 2. View of street trees Pearl Street. View looking north.

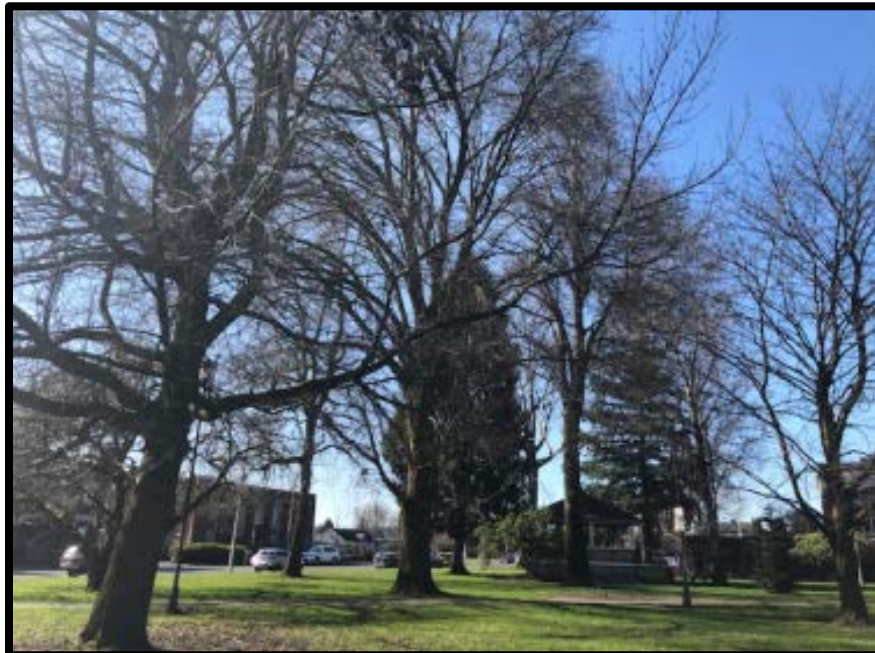
Photo 3. View of trees in Washington Park looking southwest.

Most of the trees in the park are mature and some have some twig or small branch dieback in the canopy. Four trees were found to have branches that are at a 'Moderate' risk to fail and impact targets. Dead and defective branches in these 4 trees are likely or somewhat likely to fail and impact pedestrians, vehicles, or structures in the park. Crown cleaning should be done to remove dead branches that are 1 inch diameter and larger.

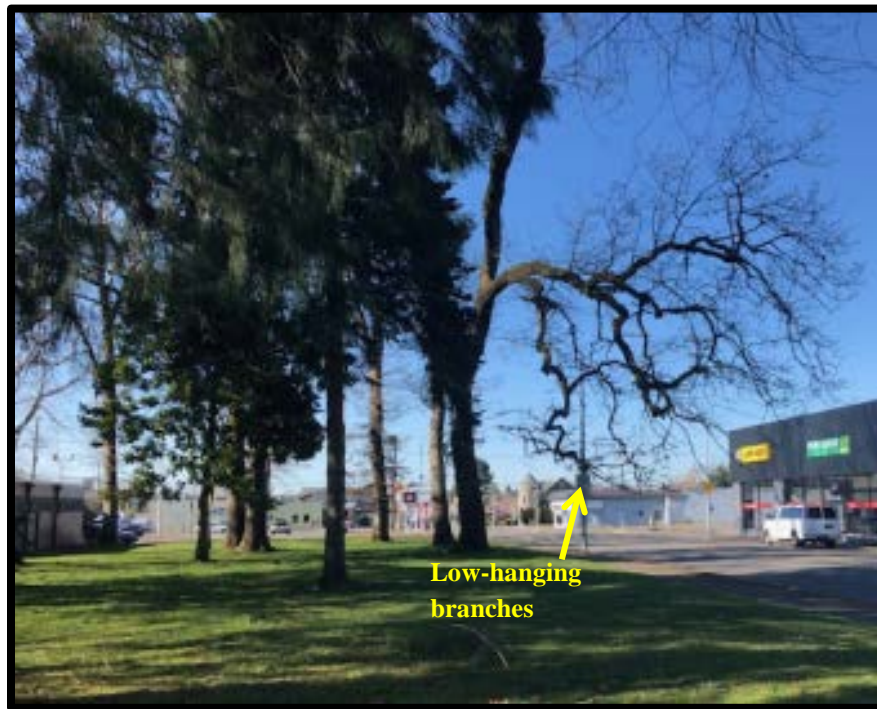
Photo 4. View of Tree #23, which should be pruned to provide clearance and to remove defective branches. View looking northwest.

23	Oregon White Oak	41	Fair	Moderate - Branches	Crown Clean, Crown Raise	
24	Magnolia	12	Good	Low	None	
25	Oregon White Oak	38	Good	Low	None	
26	Dogwood	10	Good	Low	None	
27	Dogwood	11	Fair	Low	None

Most of the park trees have low-hanging branches. These low-hanging branches should be pruned to provide at least 8 ft. of clearance over sidewalks and landscaped areas, and 15 ft. of clearance over streets. The cost of pruning trees in the park is projected to be \$1,200. The locations of all trees in Washington Park are illustrated on the aerial photo in Attachment 2.

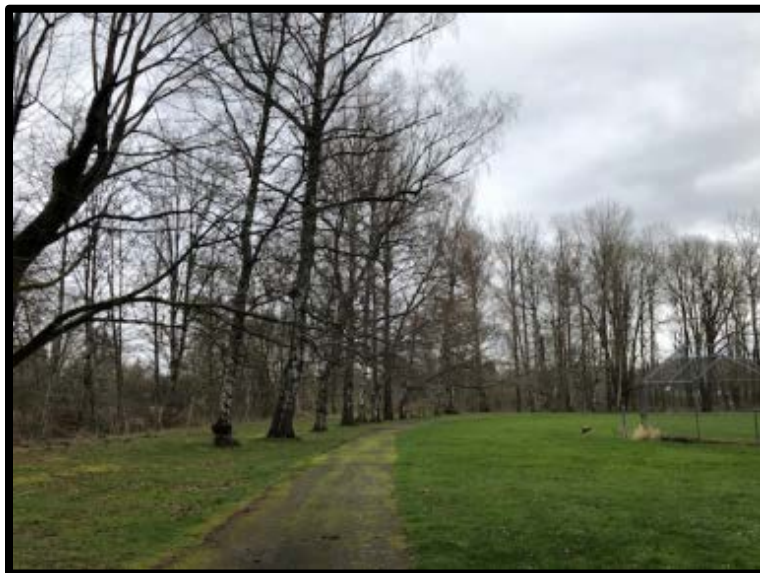
Photo 5. View of Trees in eastern portion of Riverside Park. View looking east.

Thirteen (13) of the 154 trees were found to carry a ‘Moderate’ risk rating or higher, due to decline, or the potential for branch or whole tree failure. Potential targets for tree failure include park visitors, parked vehicles, a kid’s play area, and other park structures.
