SITE PLAN REVIEW COMMITTEE
Meeting Agenda

Monday, September 9, 2024

Wetland Report

CITY OF CENTRALIA SHORT PLAT UGA-SP-24-XXXX
PORTION OF THE SE 1/4 SW 1/4 SEC 25, T 15 N, R 3 W, W.M.
CITY OF CENTRALIA, LEWIS COUNTY, WASHINGTON

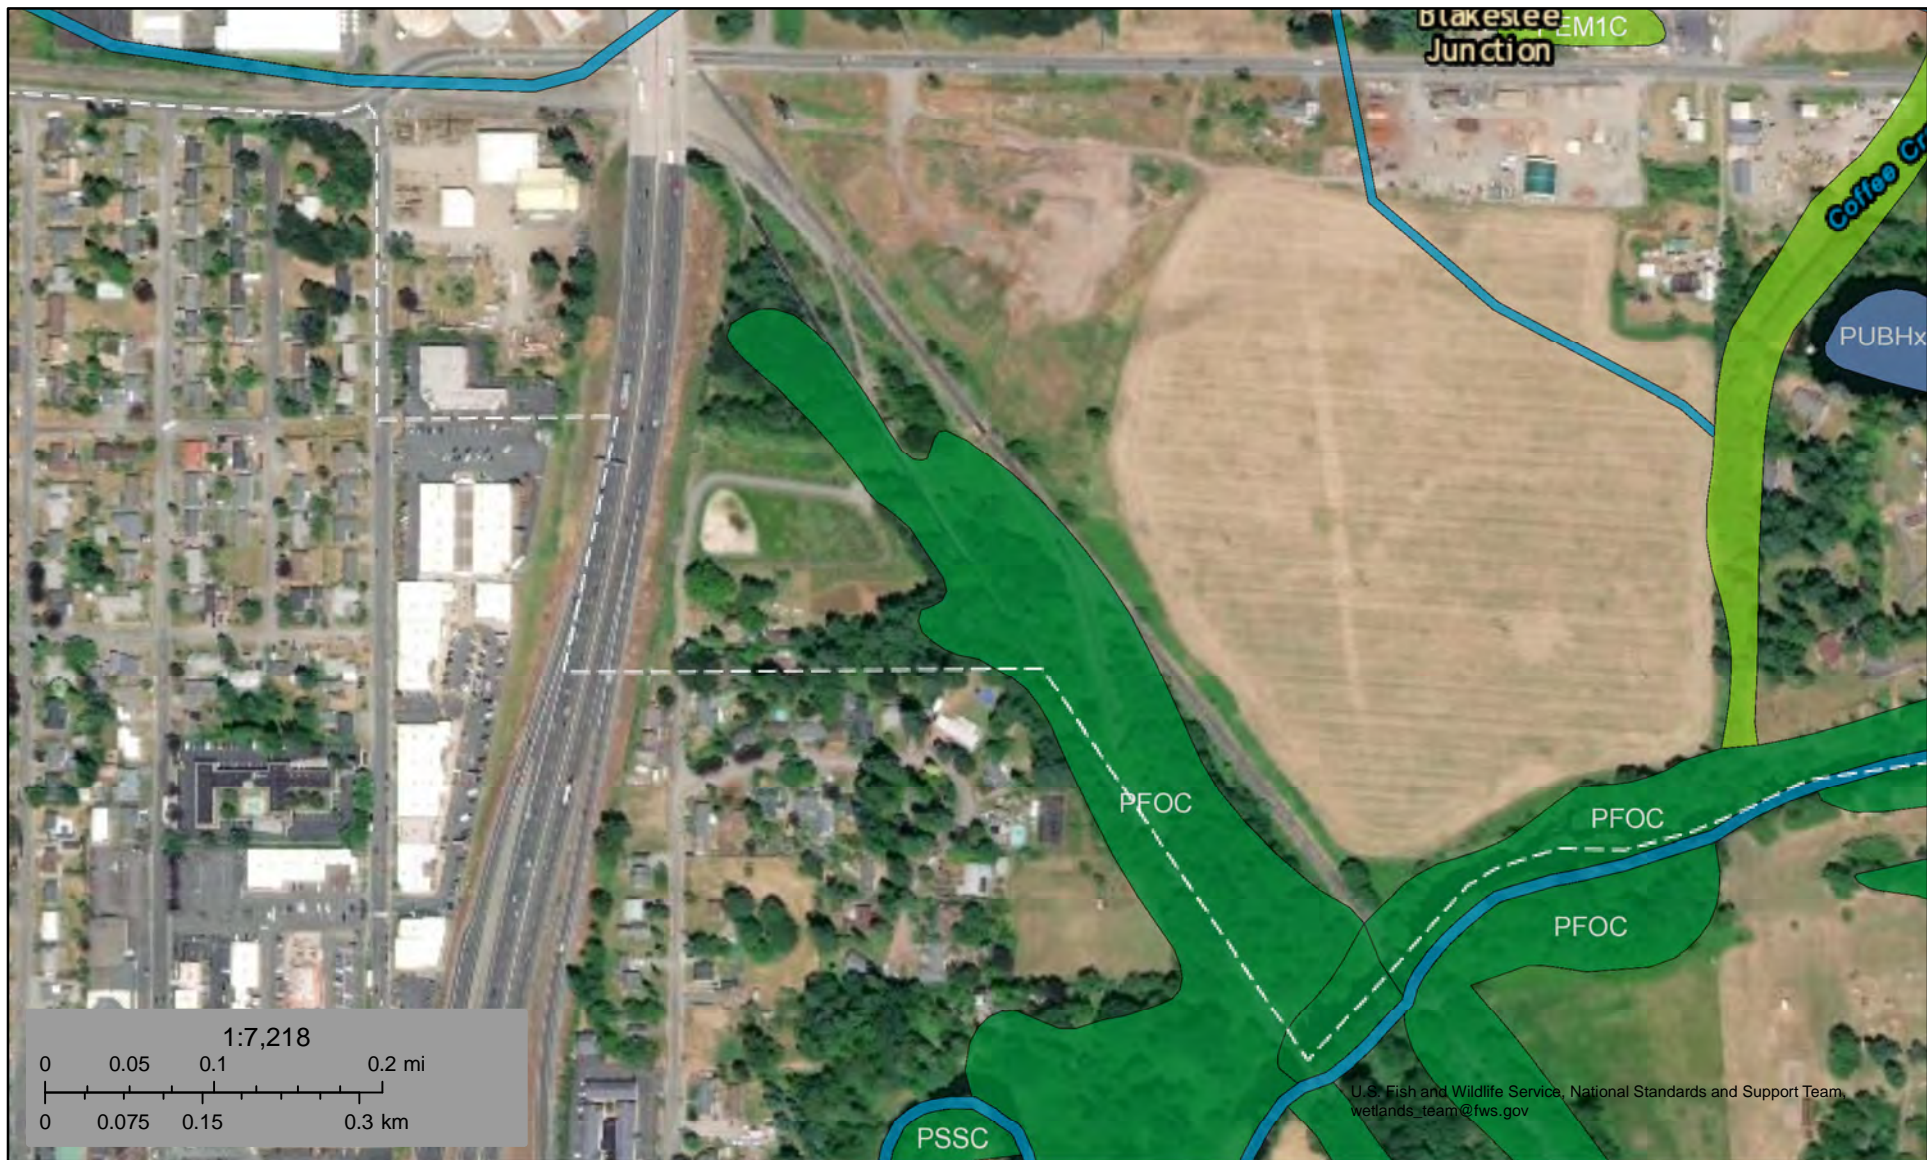
Figure 4: NWI Map

The National Wetlands Inventory (NWI) map and other maps do depict mapped wetlands within the area. It needs to be noted that the NWI maps and GeoData Center needs to be used cautiously as they compile general wetland data.

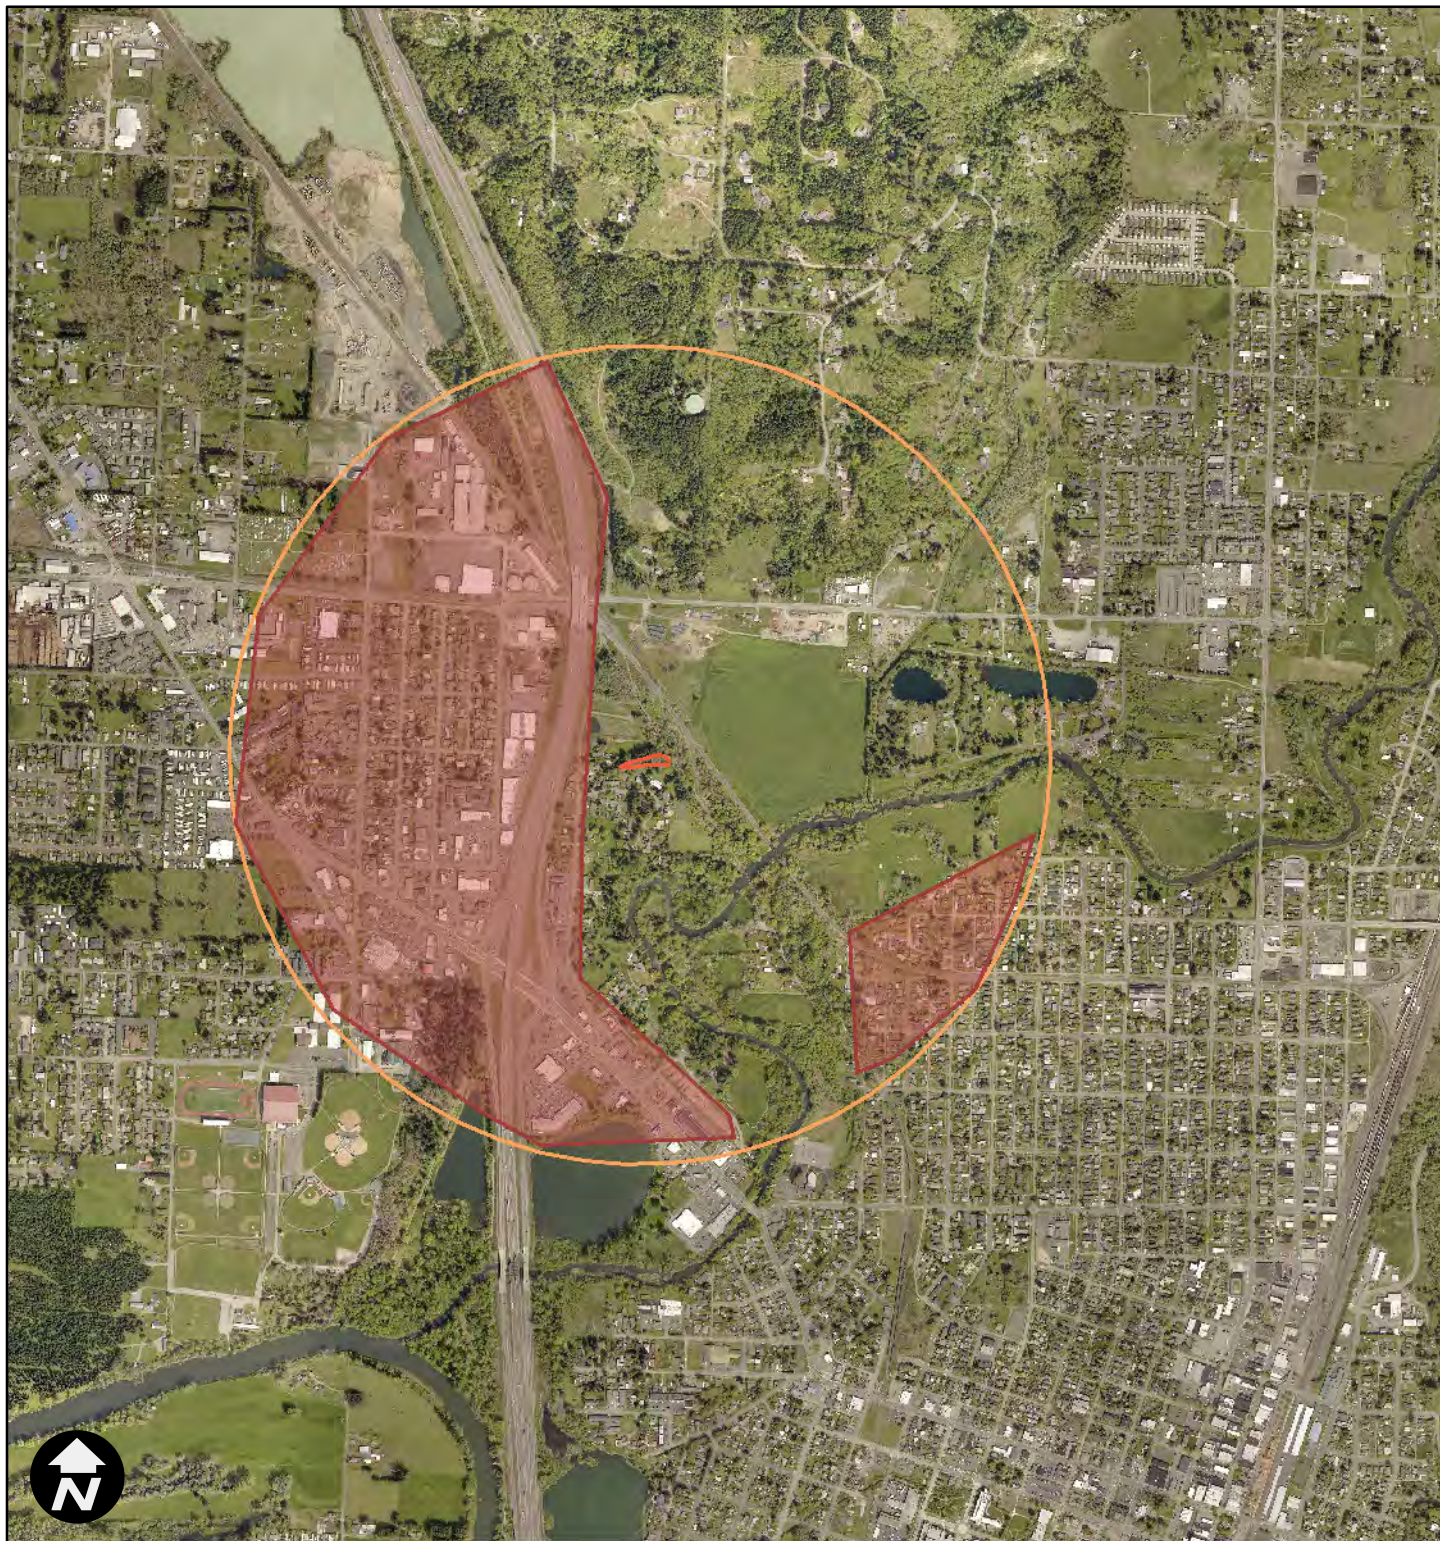
Figure 4: 1km Polygon

Legend:
Red = Wetland Boundary
Red Shade = High Intensity
Unshade = Moderate Intensity
