Borst Blockhouse

- built 1856 on the Chehalis River near the Skookumchuck River
- used as a residence 1857
- moved in 1919 to Riverside Park
- moved in 1922 to Fort Borst Park

City of Centralia, WA
Condition Assessment / Preservation Plan
Borst Blockhouse

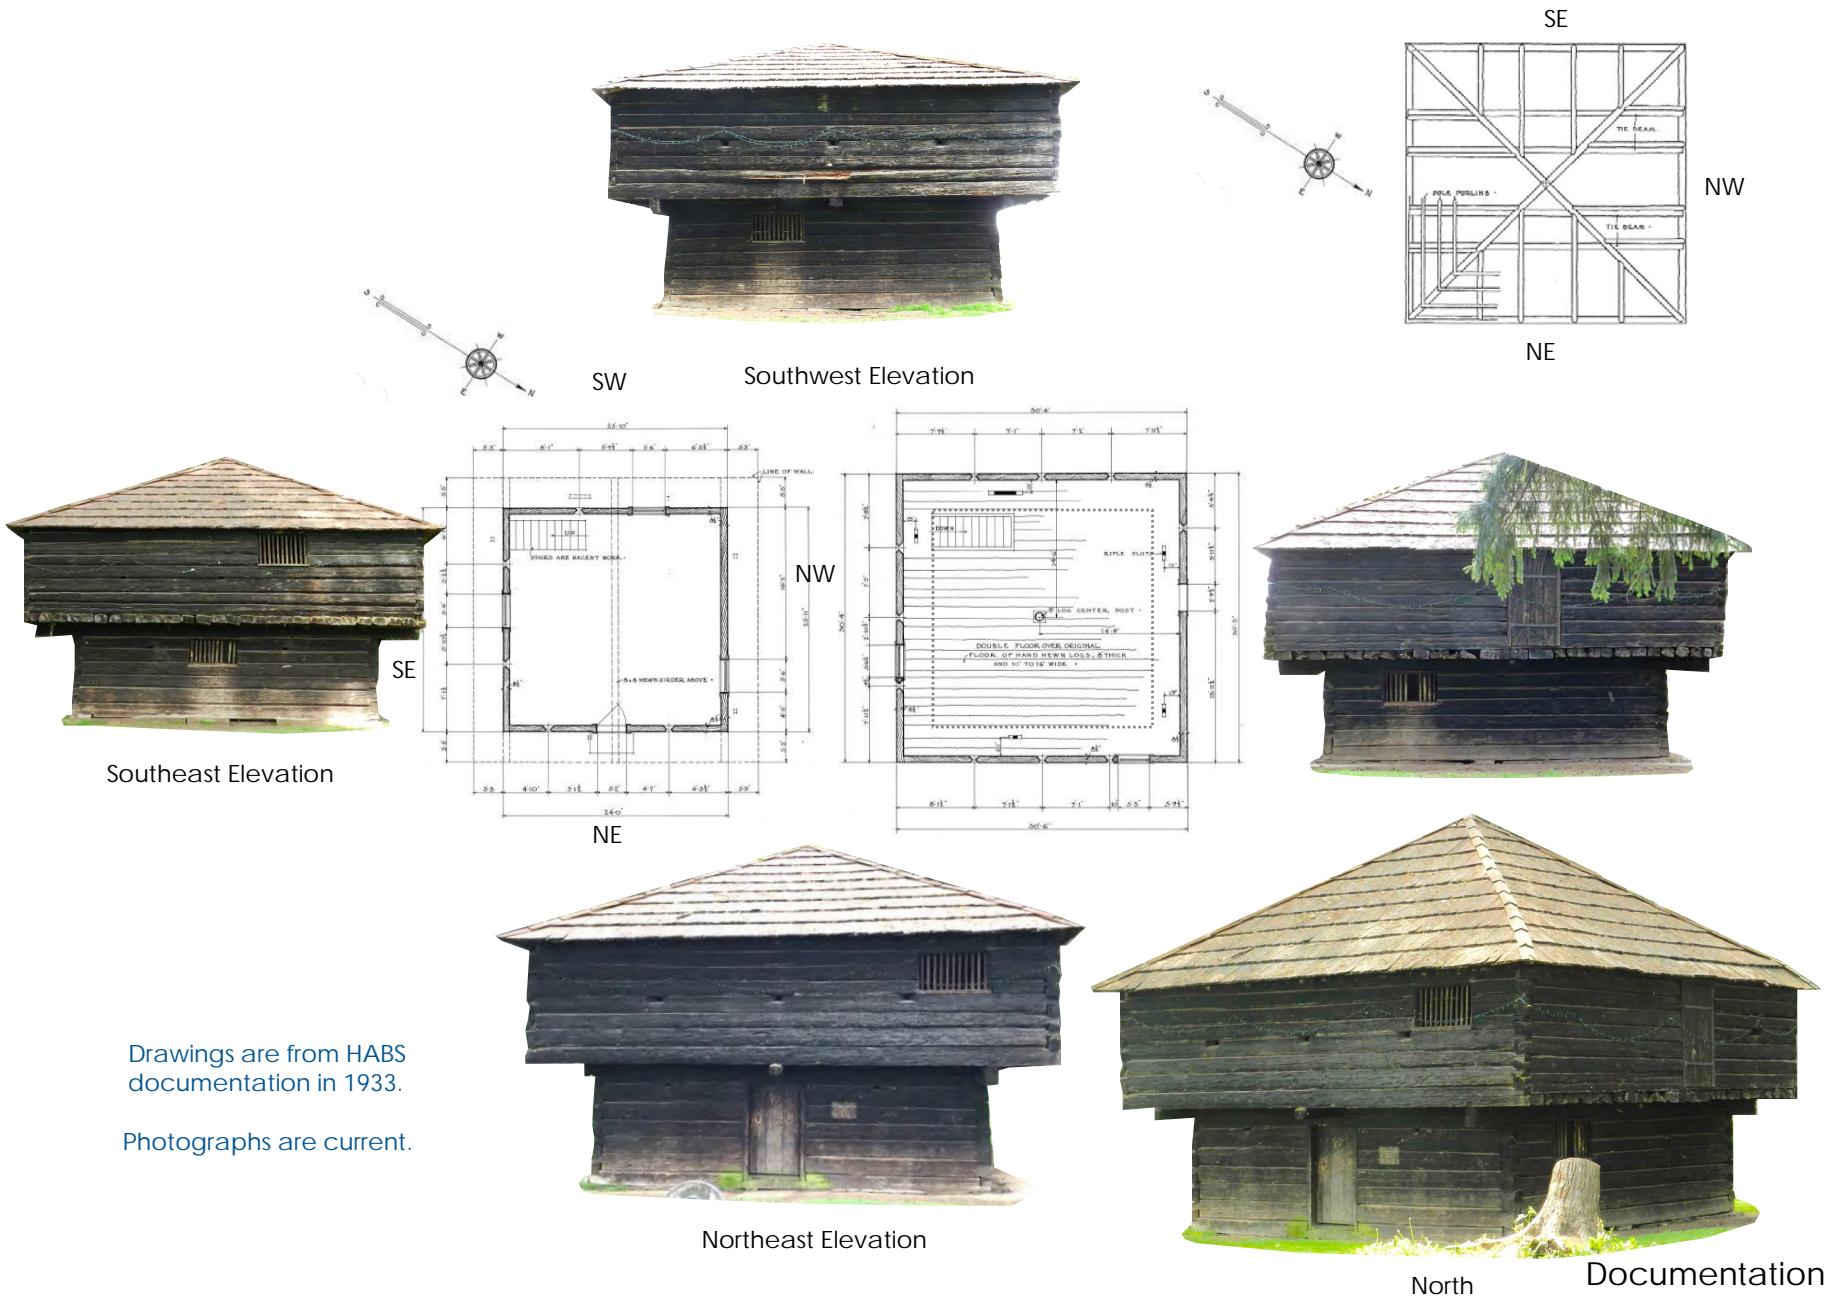
Drawings are from HABS documentation in 1933.

Photographs are current.

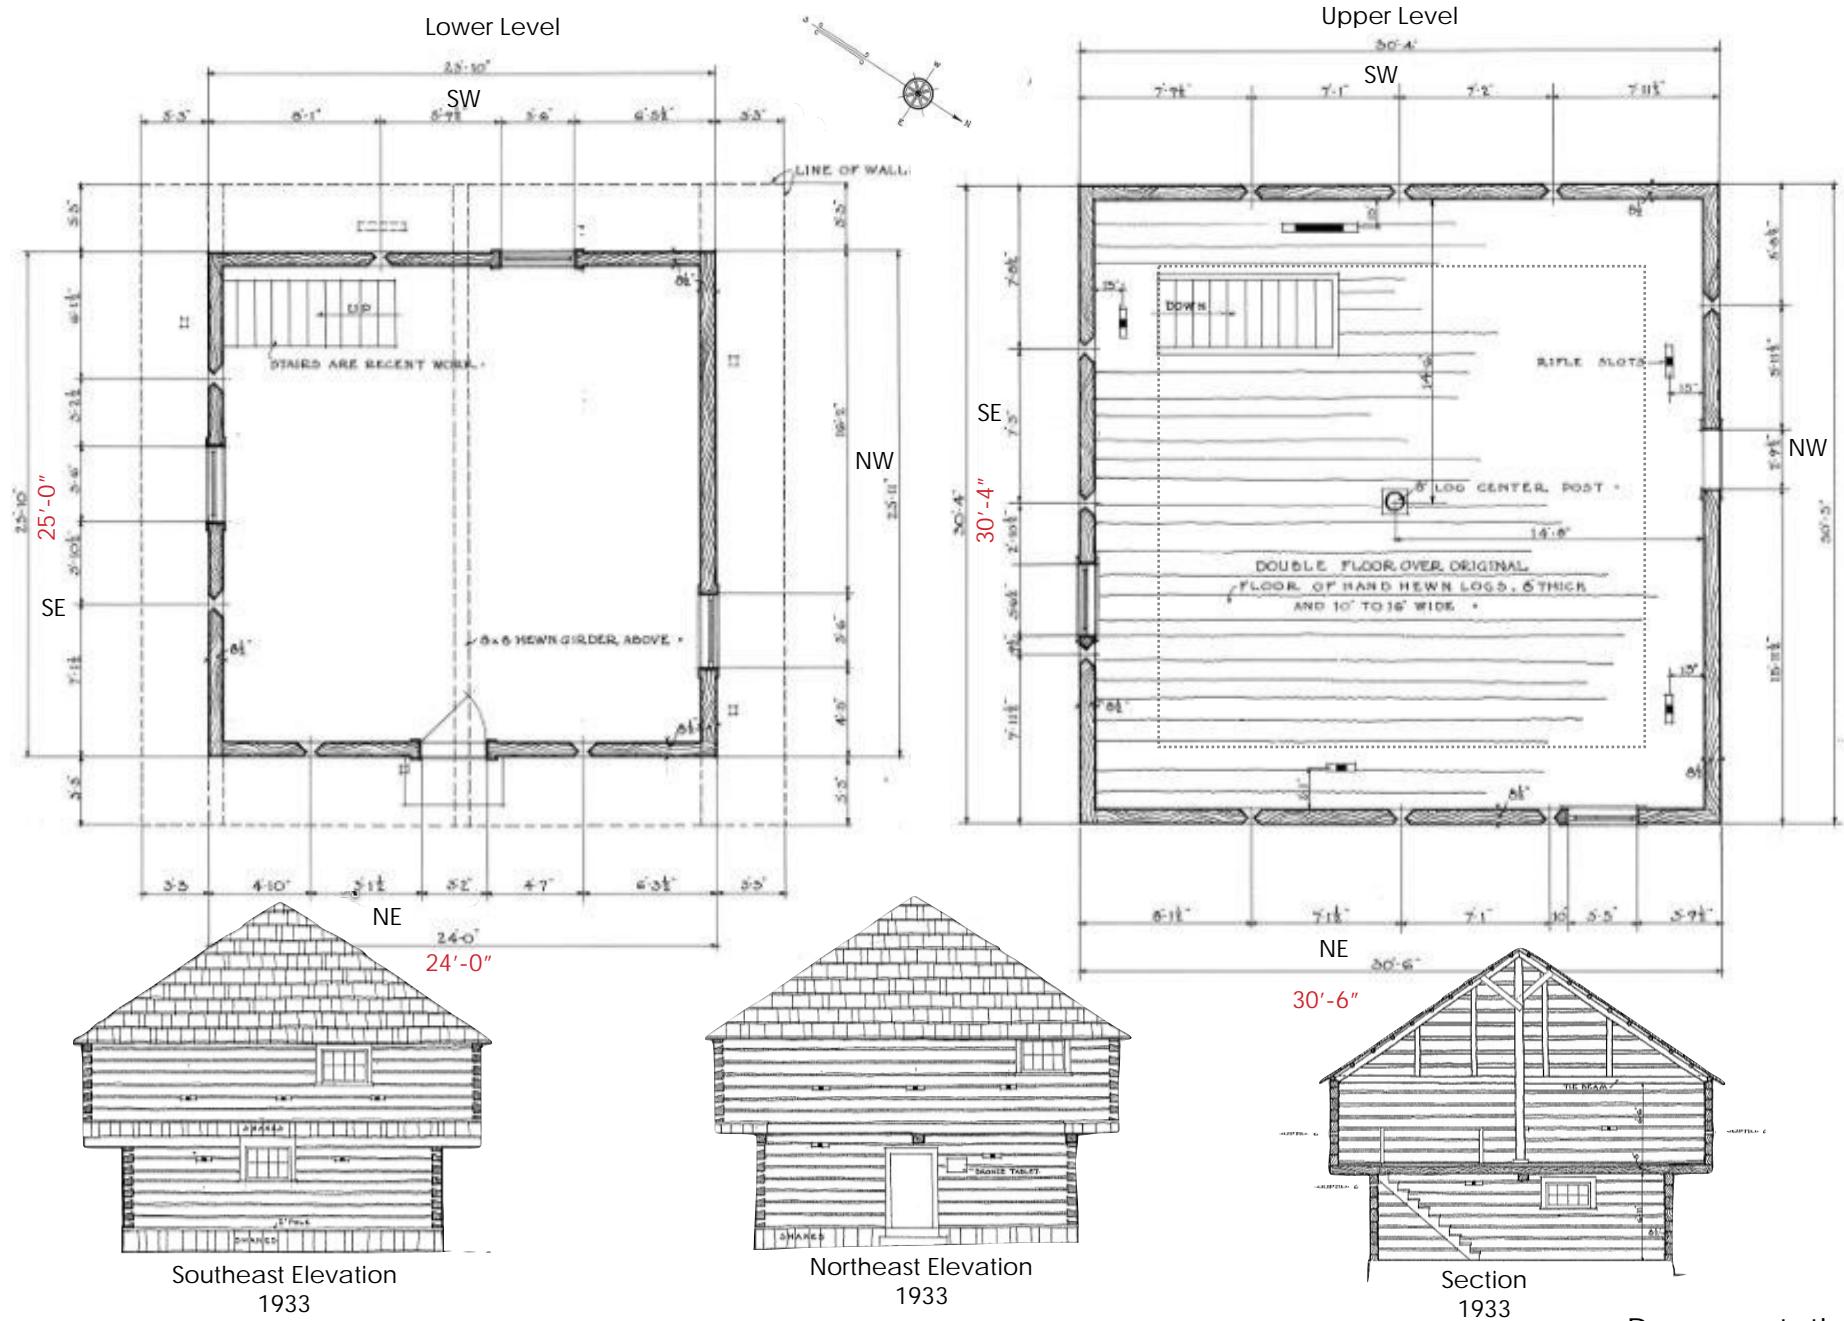
Drawings are from HABS documentation in 1933.

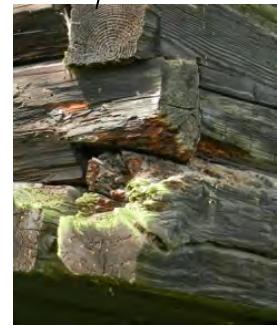
Deterioration of end of #1

Decayed log ends

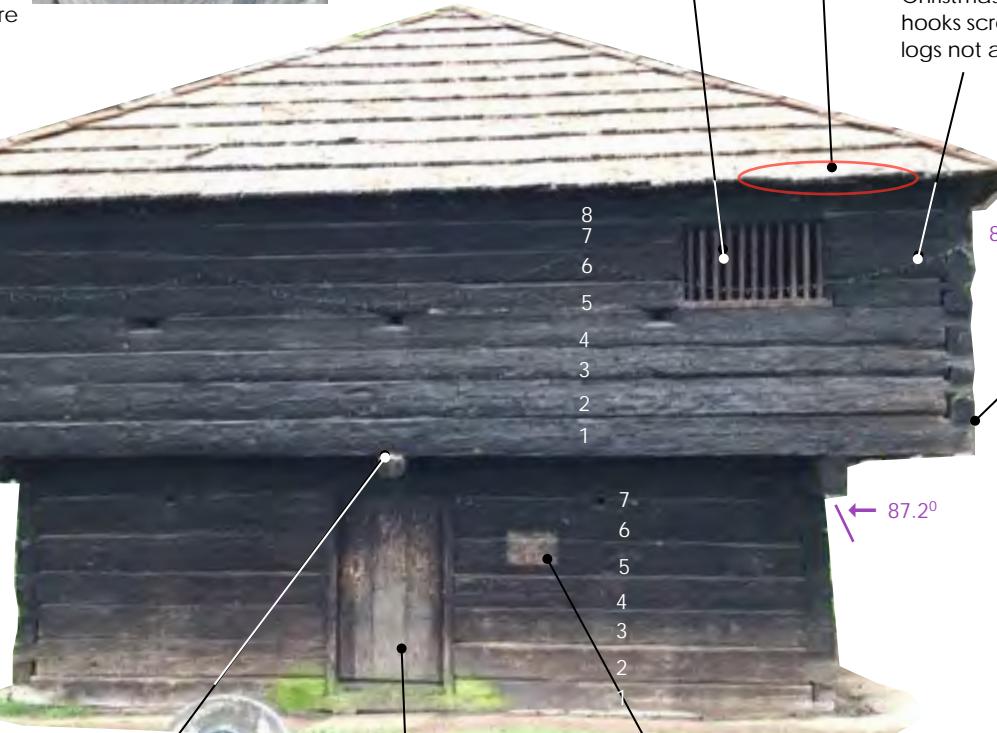
Northeast Elevation
Condition

Deterioration of end of beam

Plank door w/ strap hinges
Locking bolt
Not historic; satisfactory for now
Planks scuffed, jamb worn at lock bolt

Plaque missing

Wood rods in slabs with bark
Not historic; satisfactory for now

Shakes not laying flat; suspect
leaks to logs

Christmas lights hanging on
hooks screwed into historic
logs not appropriate

Decayed
log ends

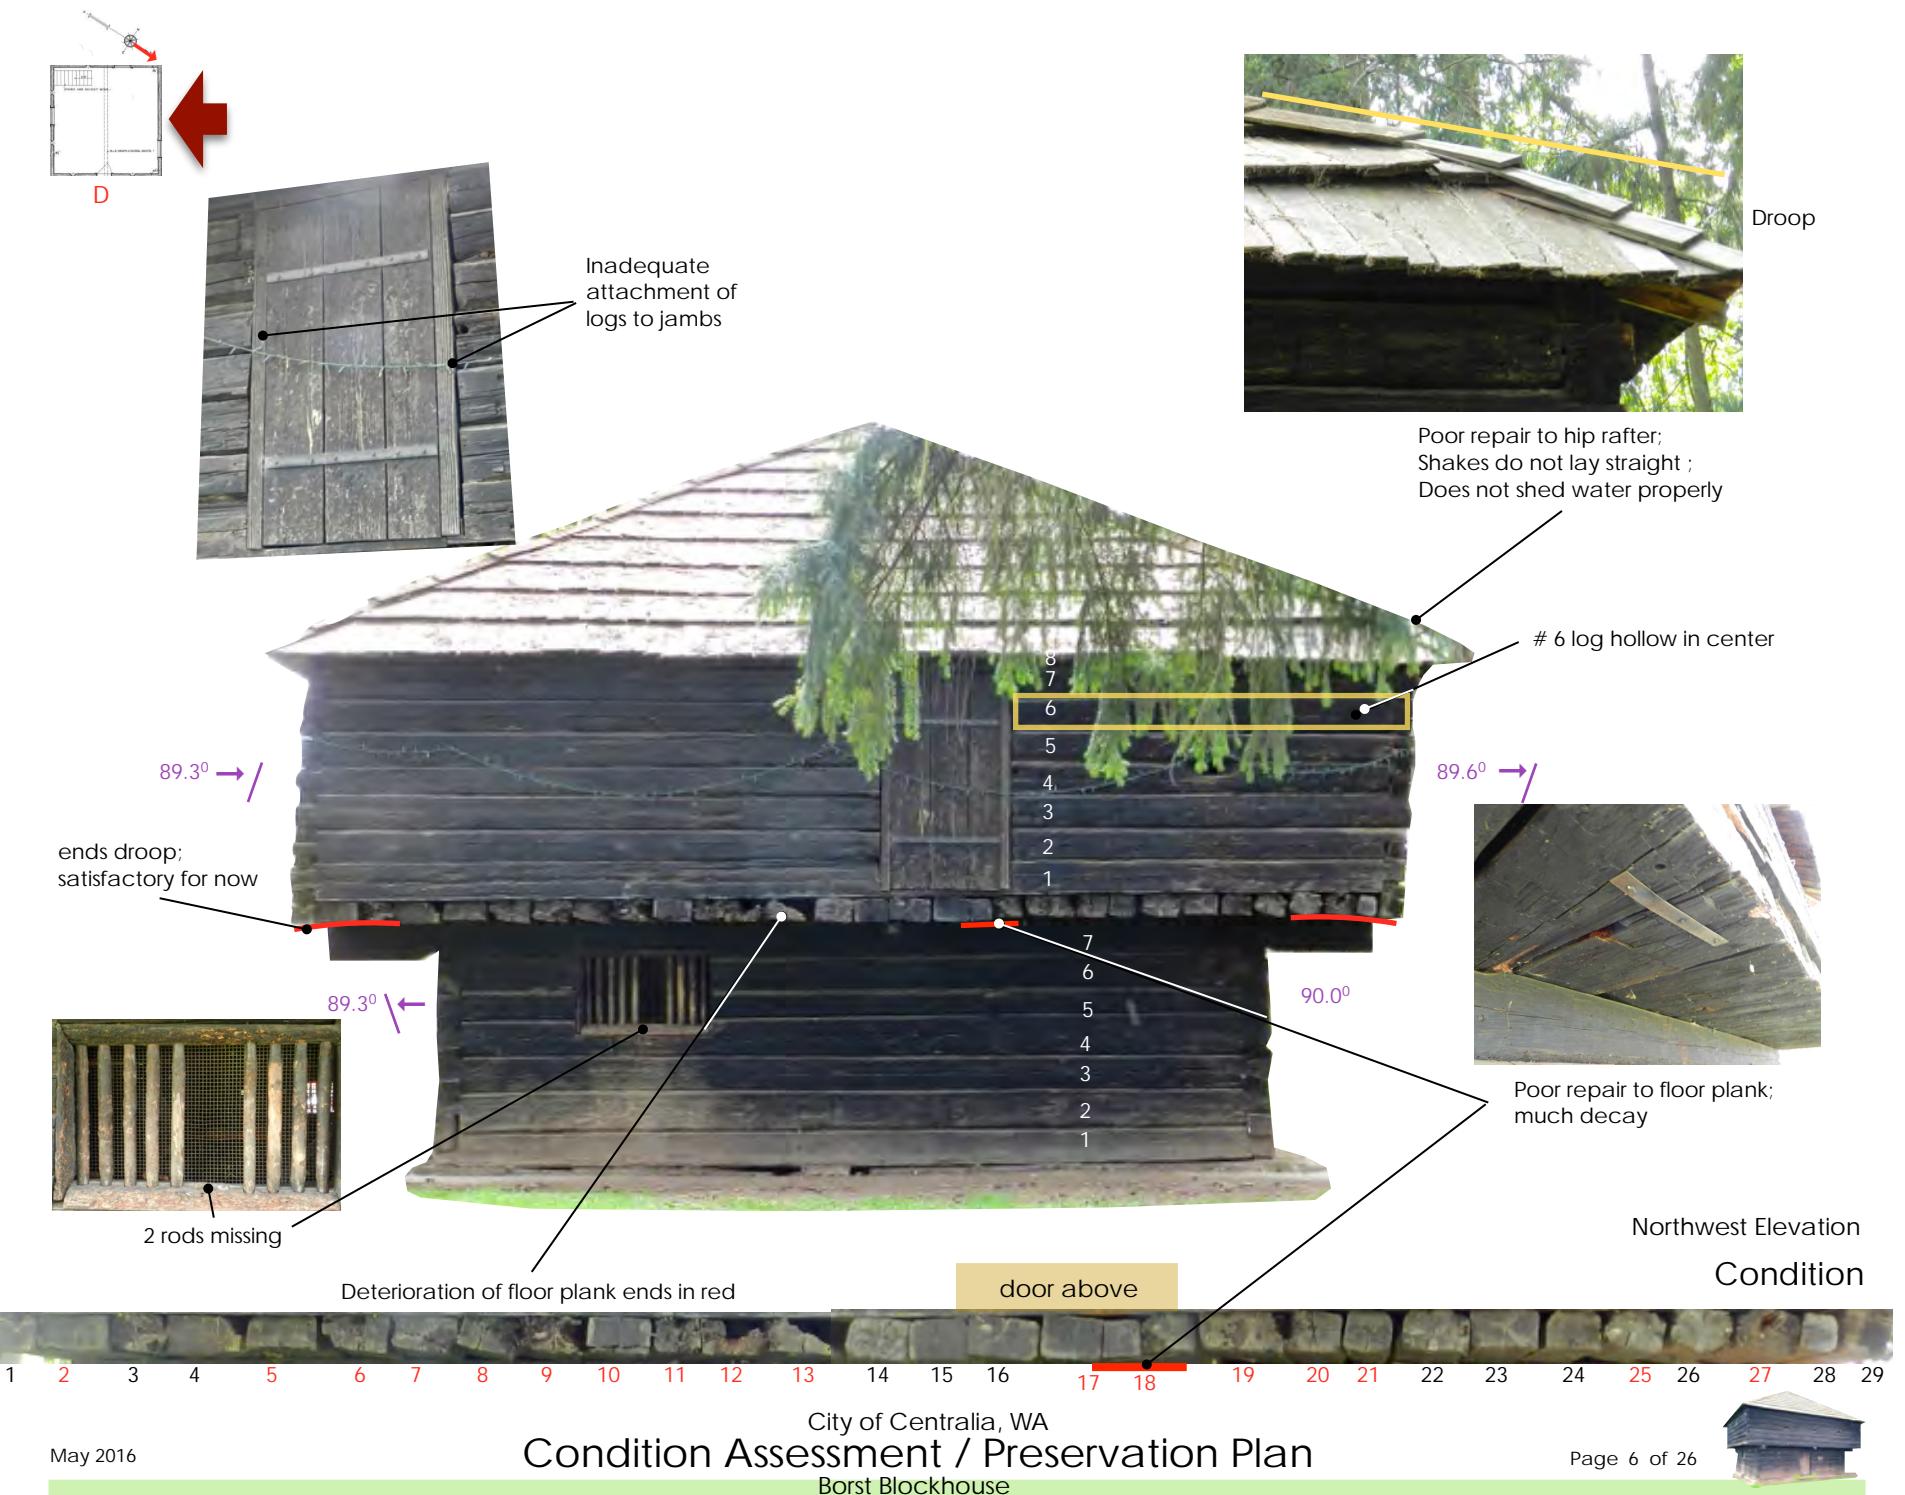
Decayed log ends: Logs to be replaced

Condition described on NW Elevation

- Replace deteriorated logs on the upper level SW 1 & 2, SE 1 (3 logs total)

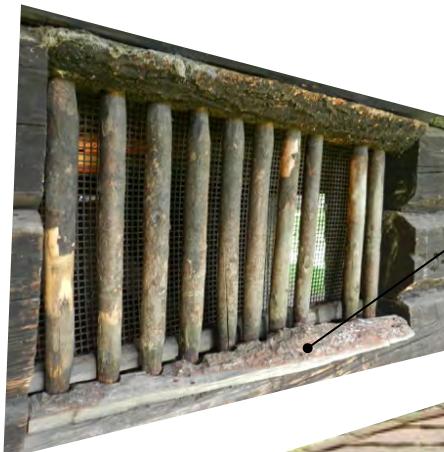
1 Bark slab sill retainer damaged;
one rod missing

Recommended Treatment:
• Replace rods / repair slab sill

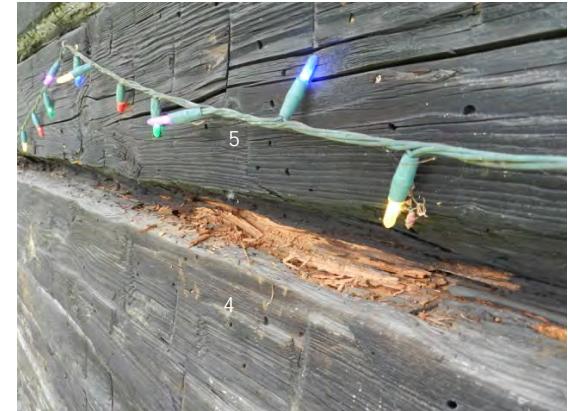
Decay pocket in top of # 4 log

Recommended Treatment:
 • Stabilize decay pocket with epoxy.
 Prepare, consolidate, patch, paint

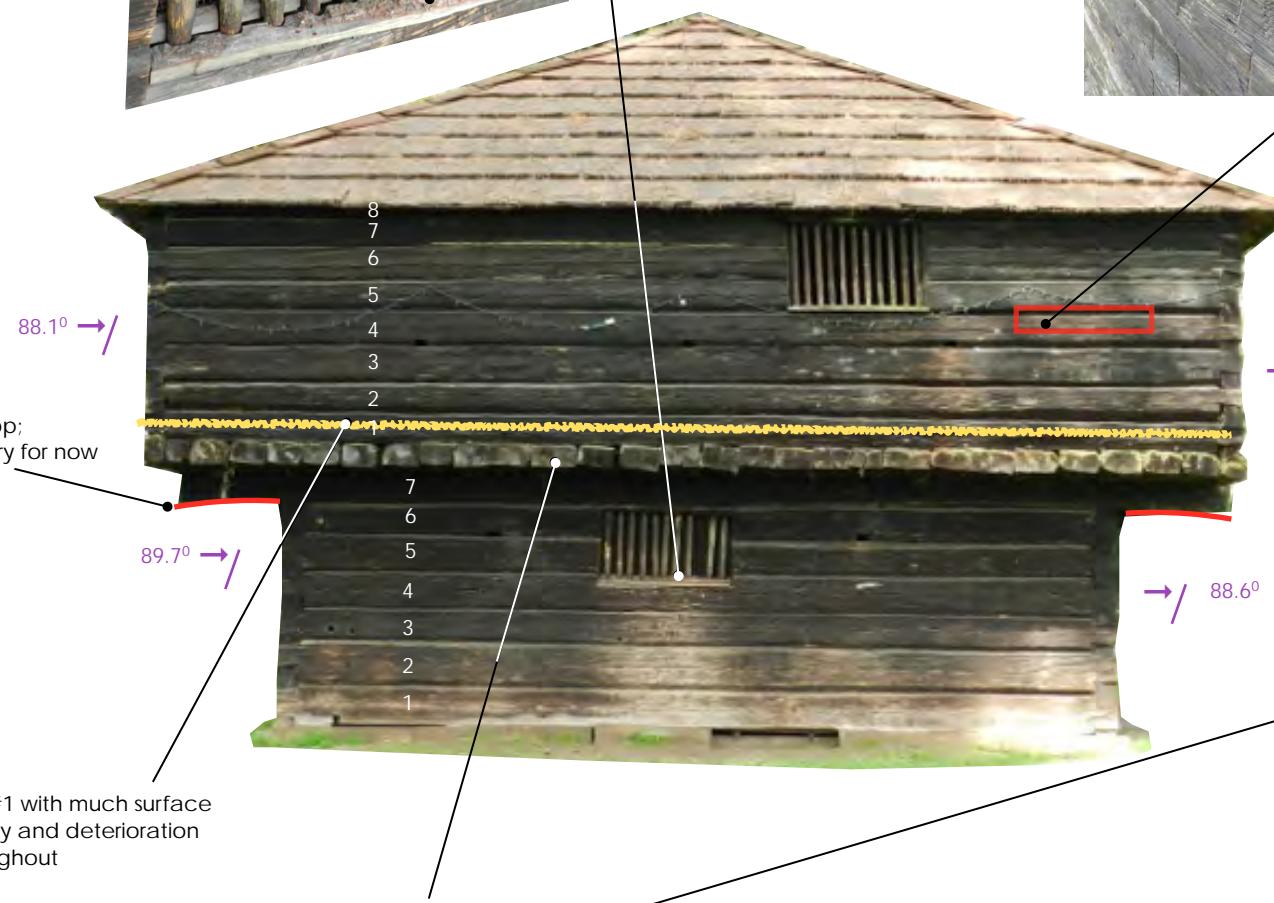
ends droop;
satisfactory for now

Log #1 with much surface decay and deterioration throughout

All floor plank ends are deteriorated

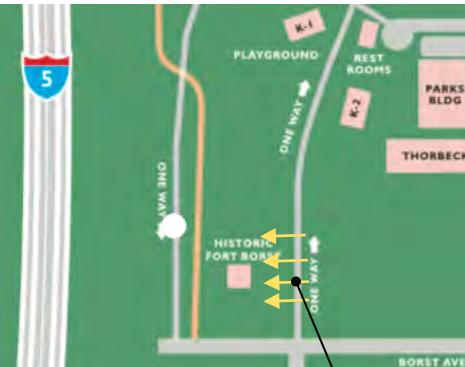
Surface water drains toward blockhouse

Surface water drains toward blockhouse and puddles around and underneath floor

- Raise blockhouse approximately 8" from existing elevation
- Construct foundation and make drainage modifications

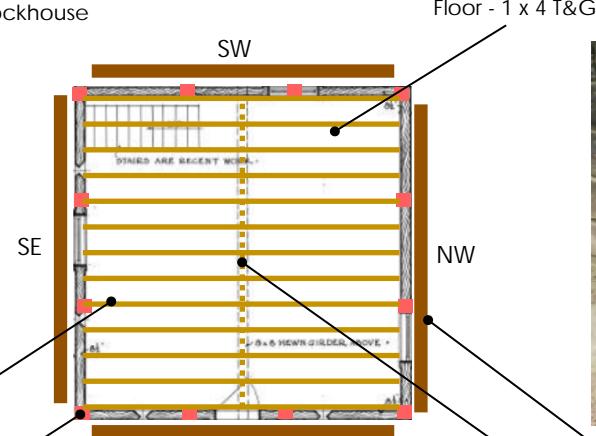
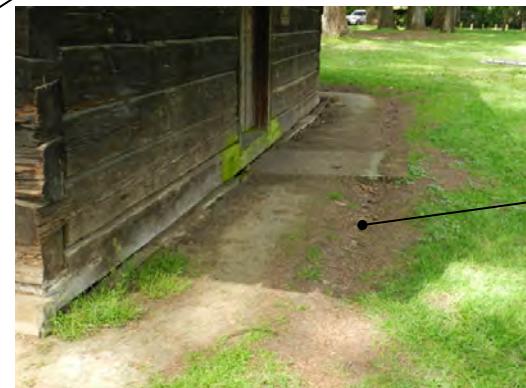
Lower Floor / Drainage / Grade Condition

Sandstone and timbers along sill logs

Floor beam

Erosion from roof runoff and surface drainage

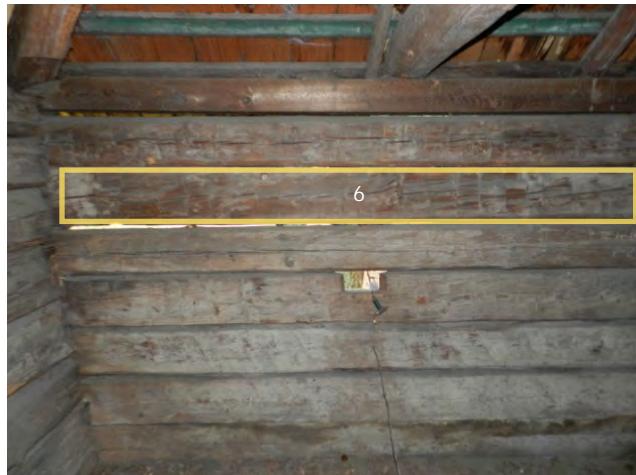
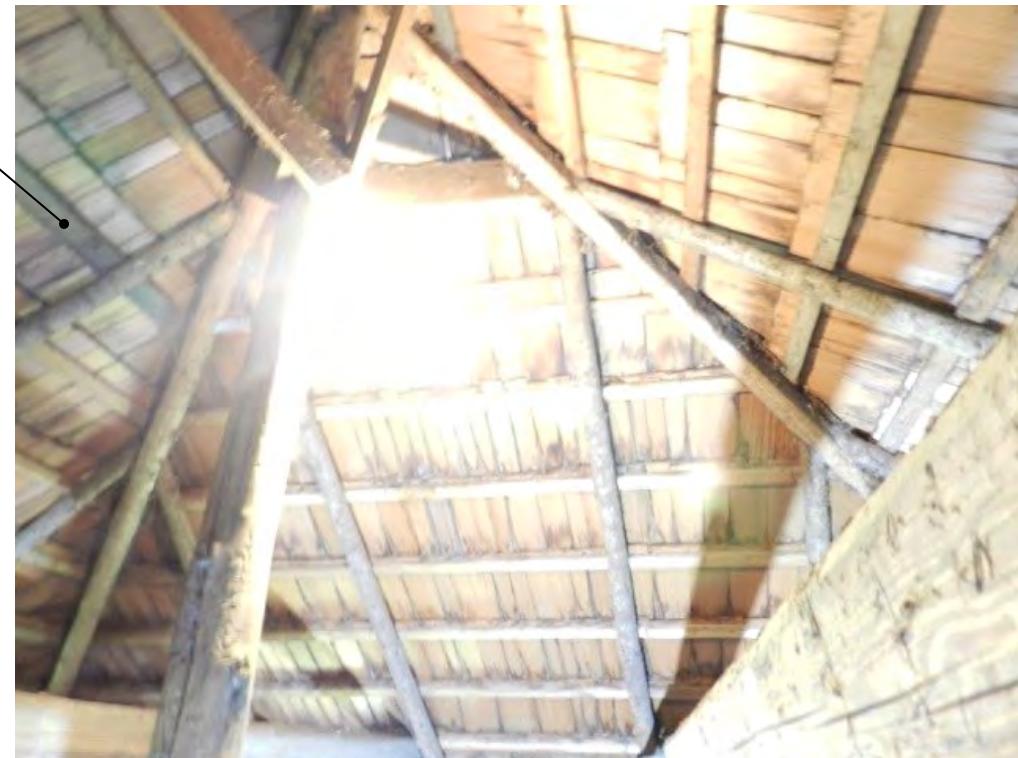
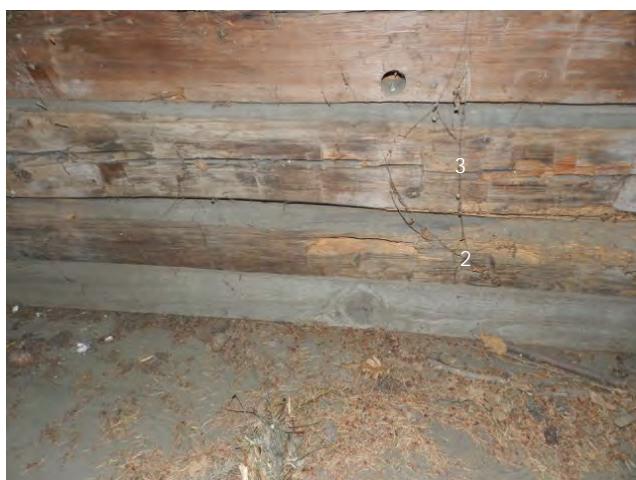
Interior - Upper Level
Upper Roof Structure
Condition

All pole purlins have
been replaced with
recycled lumber

Note: Pole purlins and
many rafters have been
replaced over time.

- Retain the existing roof structure and covering. Structurally stabilize the rafters for now with 2 x 6 scabs and refasten.
- Apply Tim-bor to all surfaces

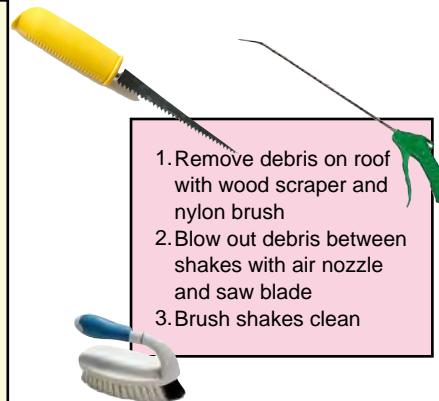
- Organic matter from trees and moss growth.
- Possible leaks at north corner
- Inappropriate repair at west hip.
- Shakes have 5 - 10 additional years of functional life

Continue to use Wolman F & P Cedar Preservative on clean shakes

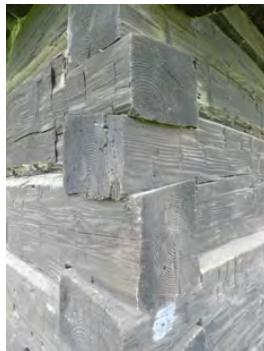
Note that most notches are tight and logs kiss closely throughout the chink space

Hew logs to match existing dimensions

Match tool marks to existing workmanship on logs

Lift logs to remove deteriorated log(s)

Do not damage existing logs when jacking

Match dovetail notches to fit existing conditions

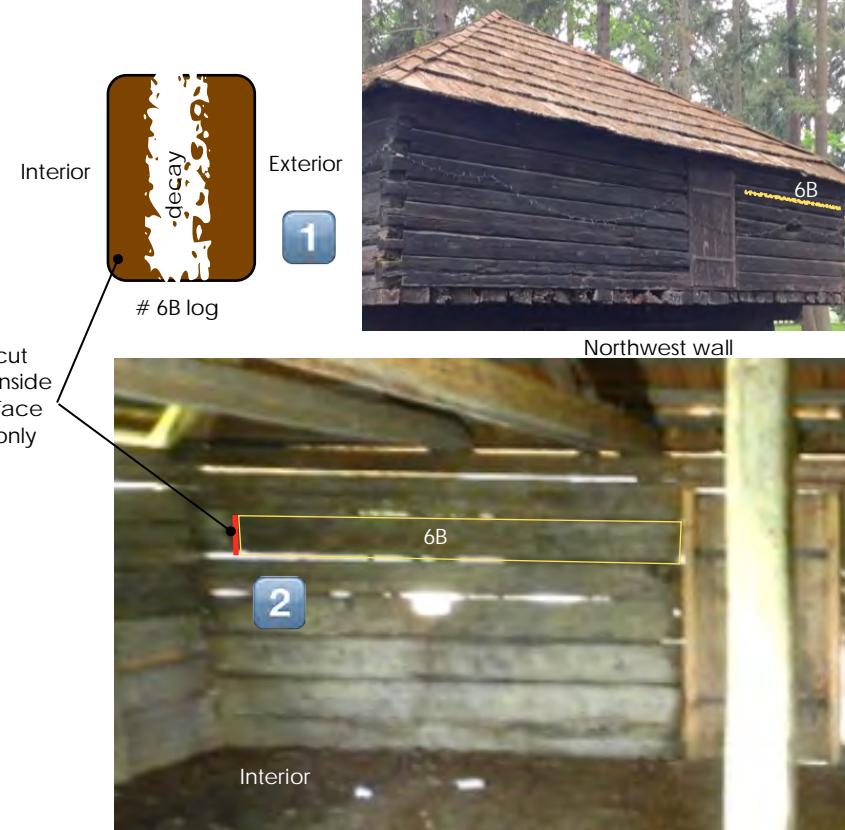
Log 6B in upper NW elevation is hollow in the center but both faces are solid and intact. The approach is to preserve the historic workmanship of the faces and retain the notch without disruption but arrest the decay and resupport the log's interior. This can be done with an internal "dutchman".

- Insert Impel rods in bottom of sill logs - all 4 elevations
- Incorporate "dutchman" in log 6B

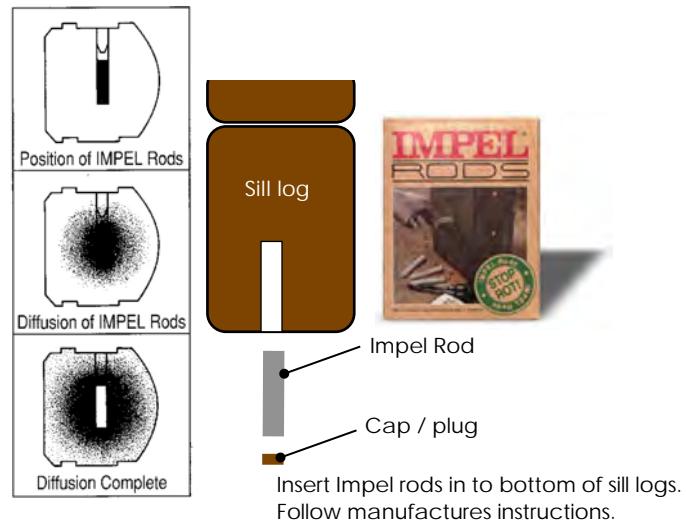
1. Log 6B with extreme decay in center
2. On interior make cut and remove interior face without damage.
3. Remove excess decay on inside faces
4. Saturate inside faces with ConServ Epoxy 100 consolidant * a flexible epoxy that will stabilize the interior. Follow manufacturer's directions.
5. Install wood "dutchman" plank to support the two faces. Use appropriate fasteners that will not be visible. Epoxy with fiberglass rods is recommended.
6. Reassemble inner face into position

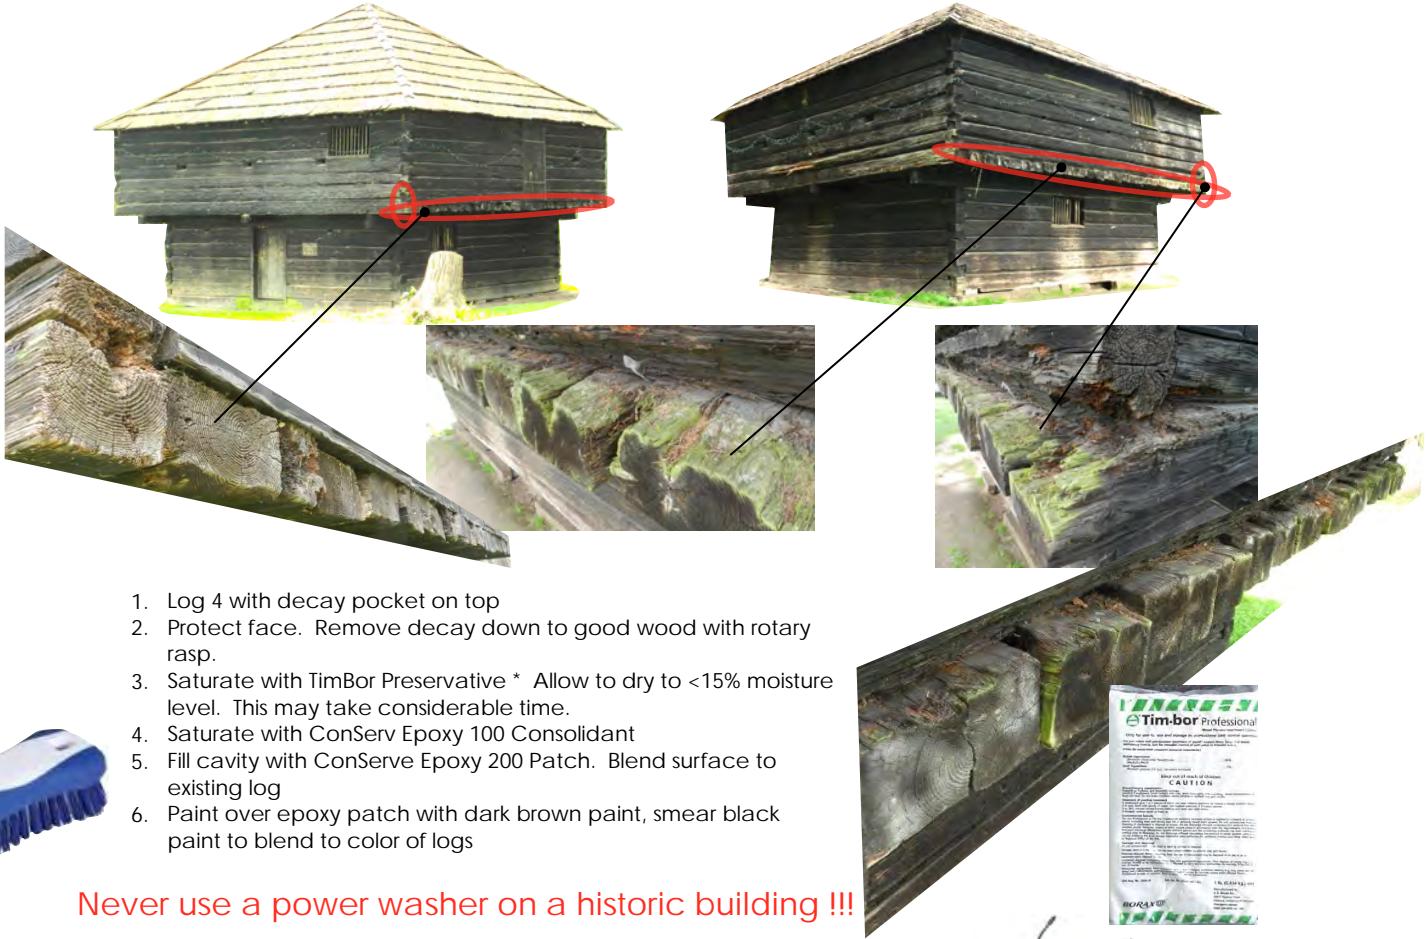
1. Log 4 with decay pocket on top
2. Protect face. Remove decay down to good wood with rotary rasp.
3. Saturate with TimBor Preservative * Allow to dry to <15% moisture level. This may take considerable time.
4. Saturate with ConServ Epoxy 100 Consolidant
5. Fill cavity with ConServe Epoxy 200 Patch. Blend surface to existing log
6. Paint over epoxy patch with dark brown paint, smear black paint to blend to color of logs

- Stabilize decay with epoxy. Clean, prepare decay area, consolidate, patch, paint

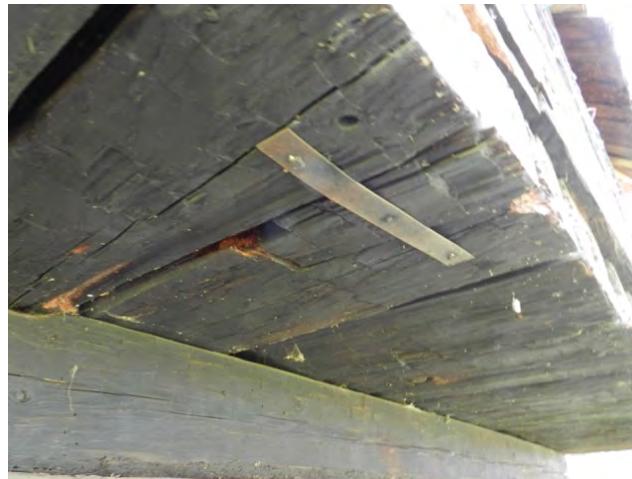
Existing condition

Condition:
Early repair to floor overhang on NW elevation at door is inappropriate

Recommended Treatment:
• Replace deteriorated flooring overhang planks with scarf joint and fiberglass pins

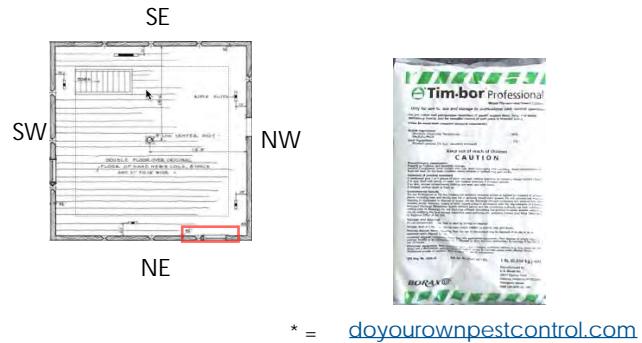
Condition:
Fungal decay in interior of SE logs 2 & 3

1. Logs 2 & 3 with much fungal decay
2. Vacuum off all loose decayed wood
3. Saturate decay areas with TimBor preservative *

Recommended Treatment:
• Treat decay with Tim-bor preservative

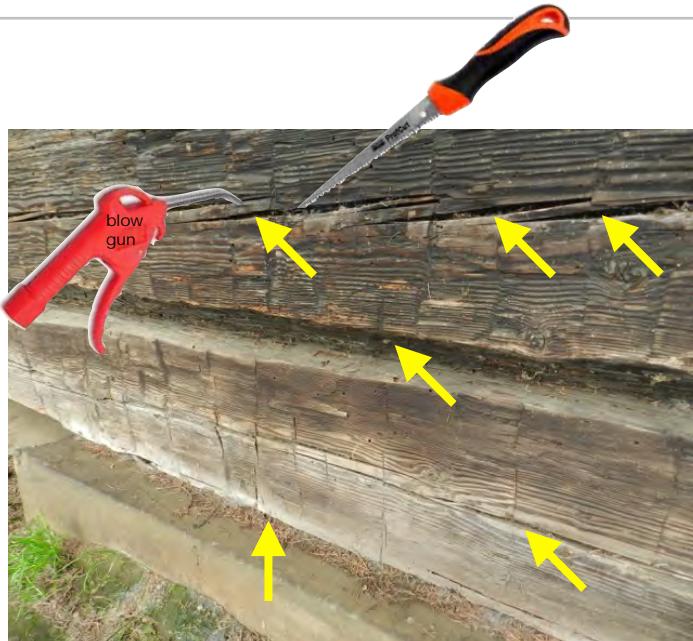
Condition:
Log checks, chink spaces and connections with dirt, pollen, organic debris

If desired, the exterior logs can be wet cleaned but it is not a necessary preservation treatment for this structure

Do not apply a finish to the logs

BoraCare preservative may be applied to deep checks or into decay pockets

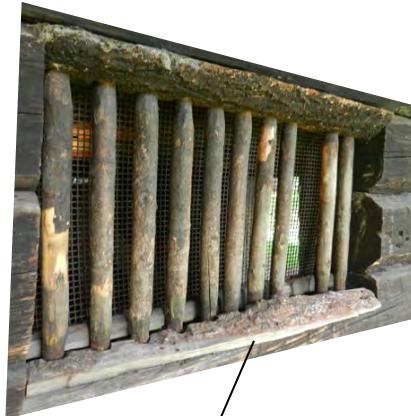
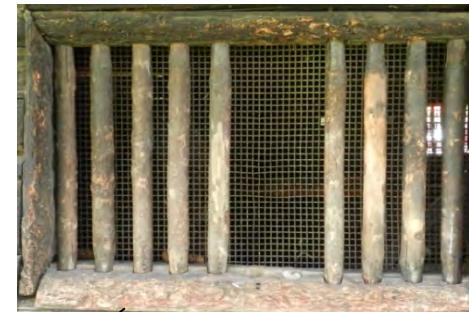
Condition:
Wood rods missing / bark slab sill damaged
Excellent ventilation throughout

Replace missing wood rods

Attempt to repair slab sill rather than replacement

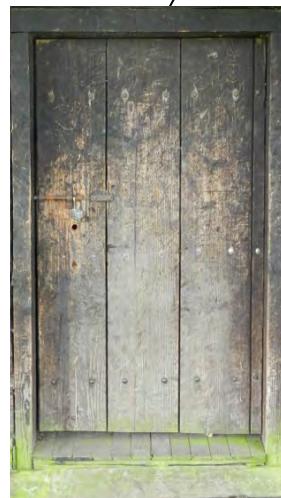
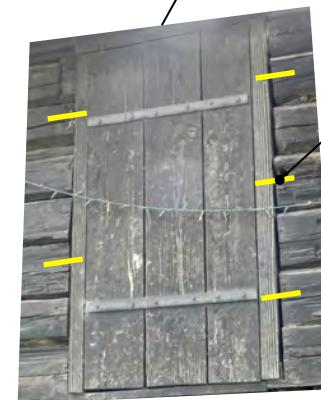
Upper door jambs not adequately attached to wall logs

Each log is to have one spike through the door jamb

Assure that upper NW door is secure

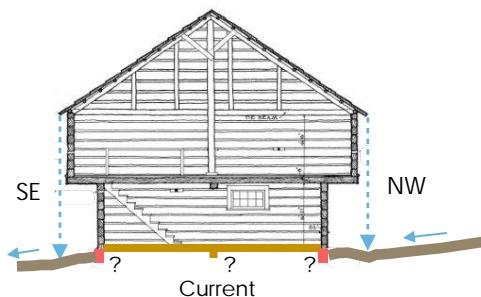
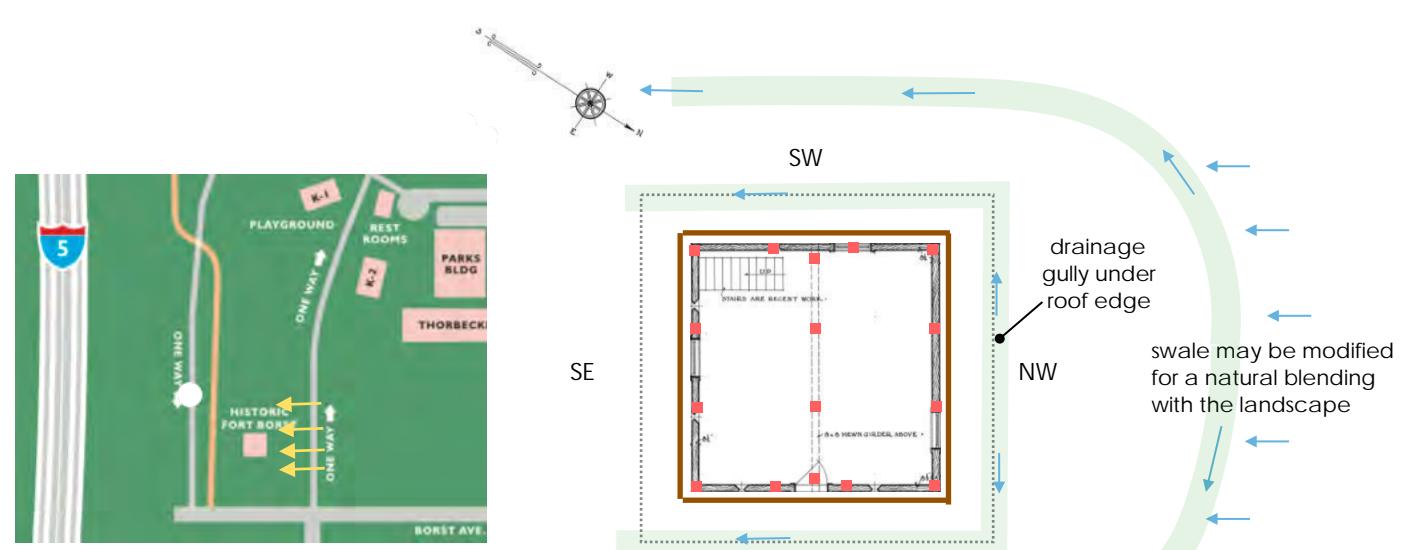
Condition:
City staff indicated water collects under the floor on occasions.

The grade surrounding the blockhouse slopes toward the NW elevation

Recommend saturating joists and flooring with Tim-bor preservative when accessible.

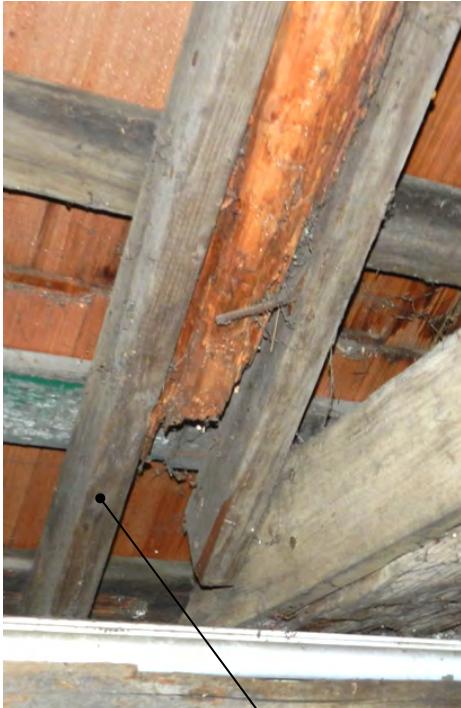
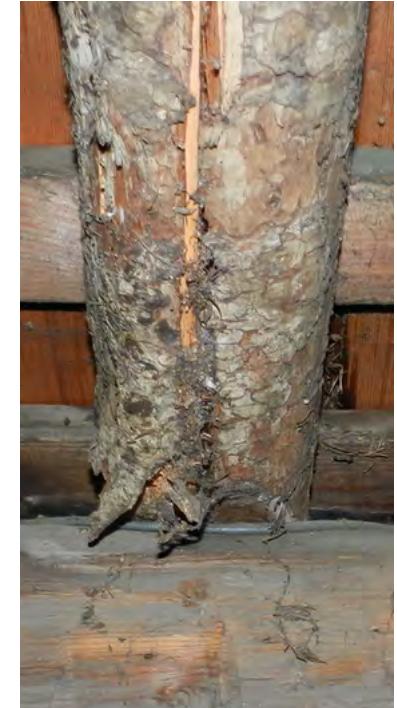
Some of the rafters are so deteriorated that scabs have been nailed to the sides of many rafters. Others remain with minimal support.

Identified rafters to be fastened to the plate log with Z-MAX 2 in. x 4 in. 12-Gauge Galvanized Medium L-Angle

Fasten scabs to hip rafters with 6" Timber-Loc screws

Identified rafters - remove existing scabs and replace with 2 x 6 - both sides.
Fasten to rafter with 4" screws.

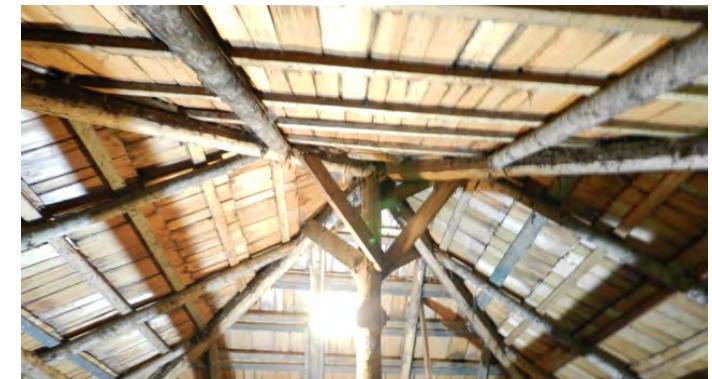
Connections of roof structure members is minimal.

Be assured that all connections are securely especially cross beams to plates
