- Tree Inventory and Risk Assessment -

CENTRALIA PARKS AND STREET TREES

Prepared by: Washington Forestry Consultants, Inc.

Date of Report: February 28, 2020

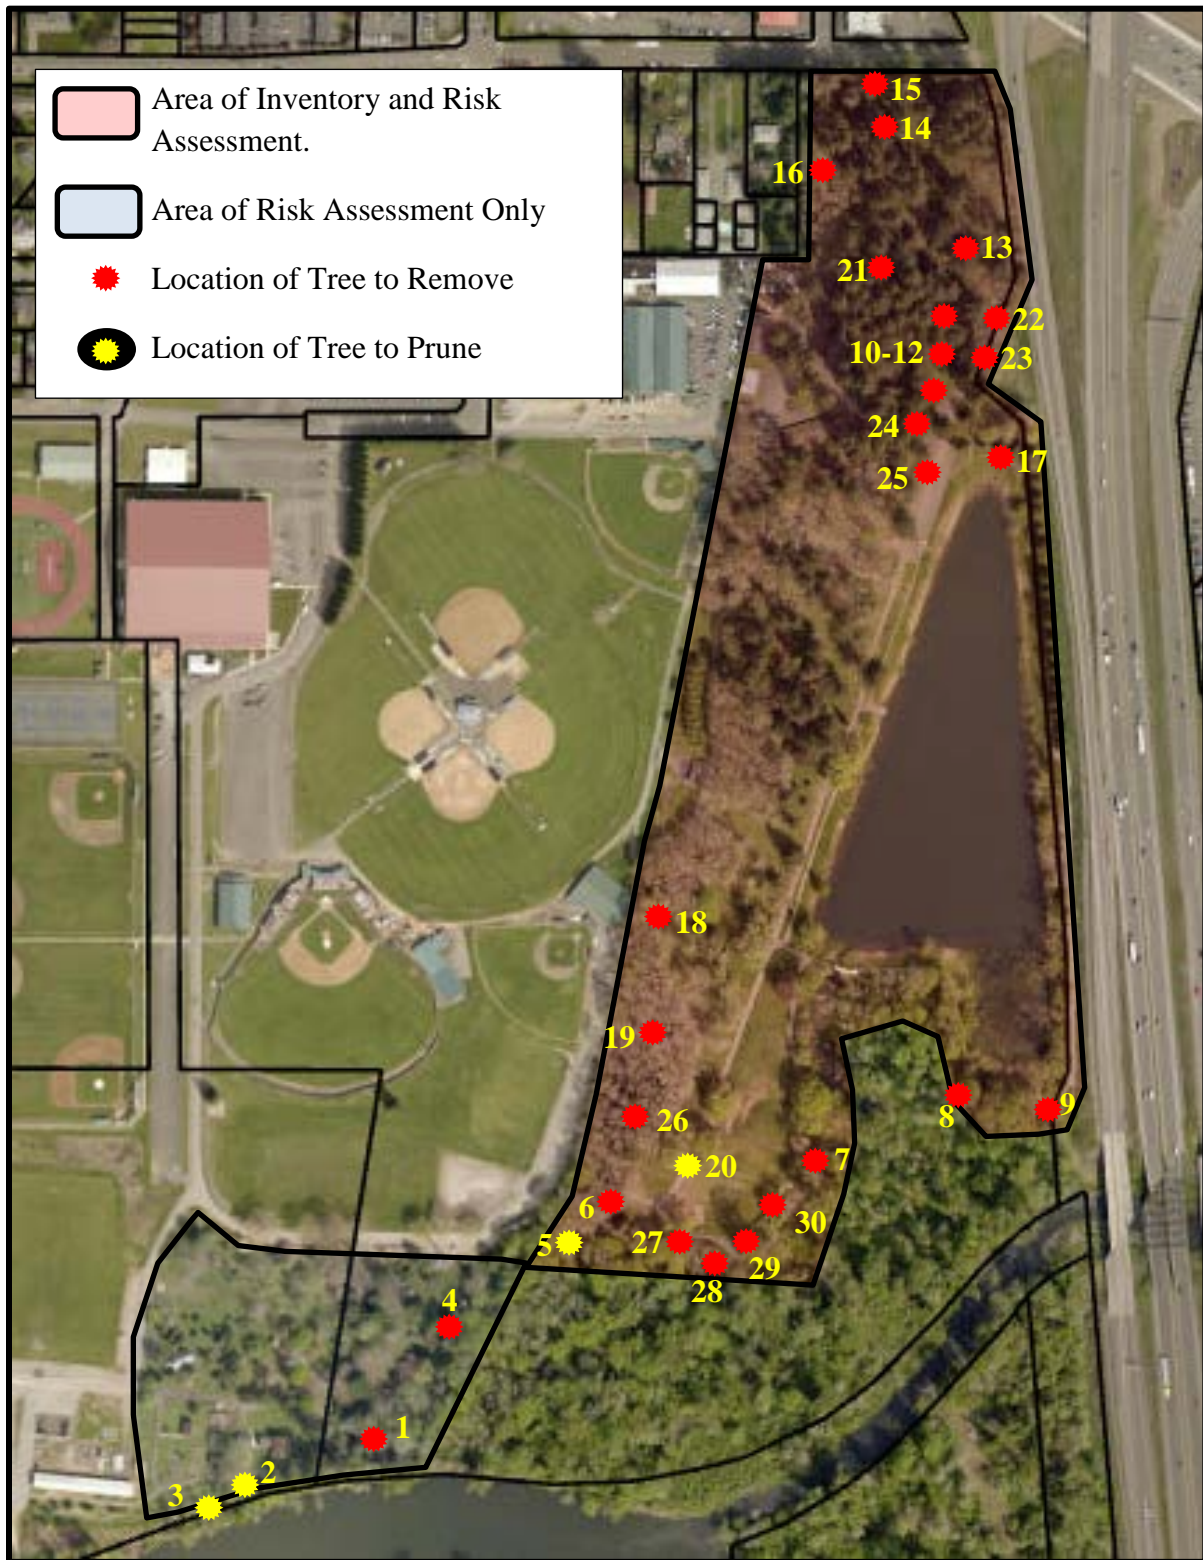
Attachment 4. Aerial Photo of Borst Park and Arboretum with Approximate Hazard Tree Locations Indicated (2019 Lewis County GIS)

23	Douglas-fir	36	Very Poor - Brown Cubicle Rot	High - Whole Tree	Freeway Entrance	Remove
24	Douglas-fir	26	Very Poor - Red Ring Rot	High - Whole Tree	Playground, Parking	Remove
25	Douglas-fir	36	Very Poor - Brown Cubicle Rot	Moderate - Whole Tree	Parking	Remove
26	Oregon White Oak	11	Dead	Moderate - Whole Tree	Park, Path	Remove
27	Bigleaf Maple	24	Very Poor - Mostly Dead	Moderate - Whole Tree	Path, Field	Remove
28	Red Alder	28	Very Poor - Mostly Dead	High - Whole Tree	Path, Rhododendrons	Remove
29	Red Alder	32	Very Poor - Mostly Dead	High - Whole Tree	Path, Rhododendrons	Remove
30	Red Alder	18, 20	Very Poor - Mostly Dead	High - Whole Tree	Path, Pedestrians	Remove
