# Centralia/Chehalis Area 2007 Flood High Water Marks (HWM)

Lewis County, Washington

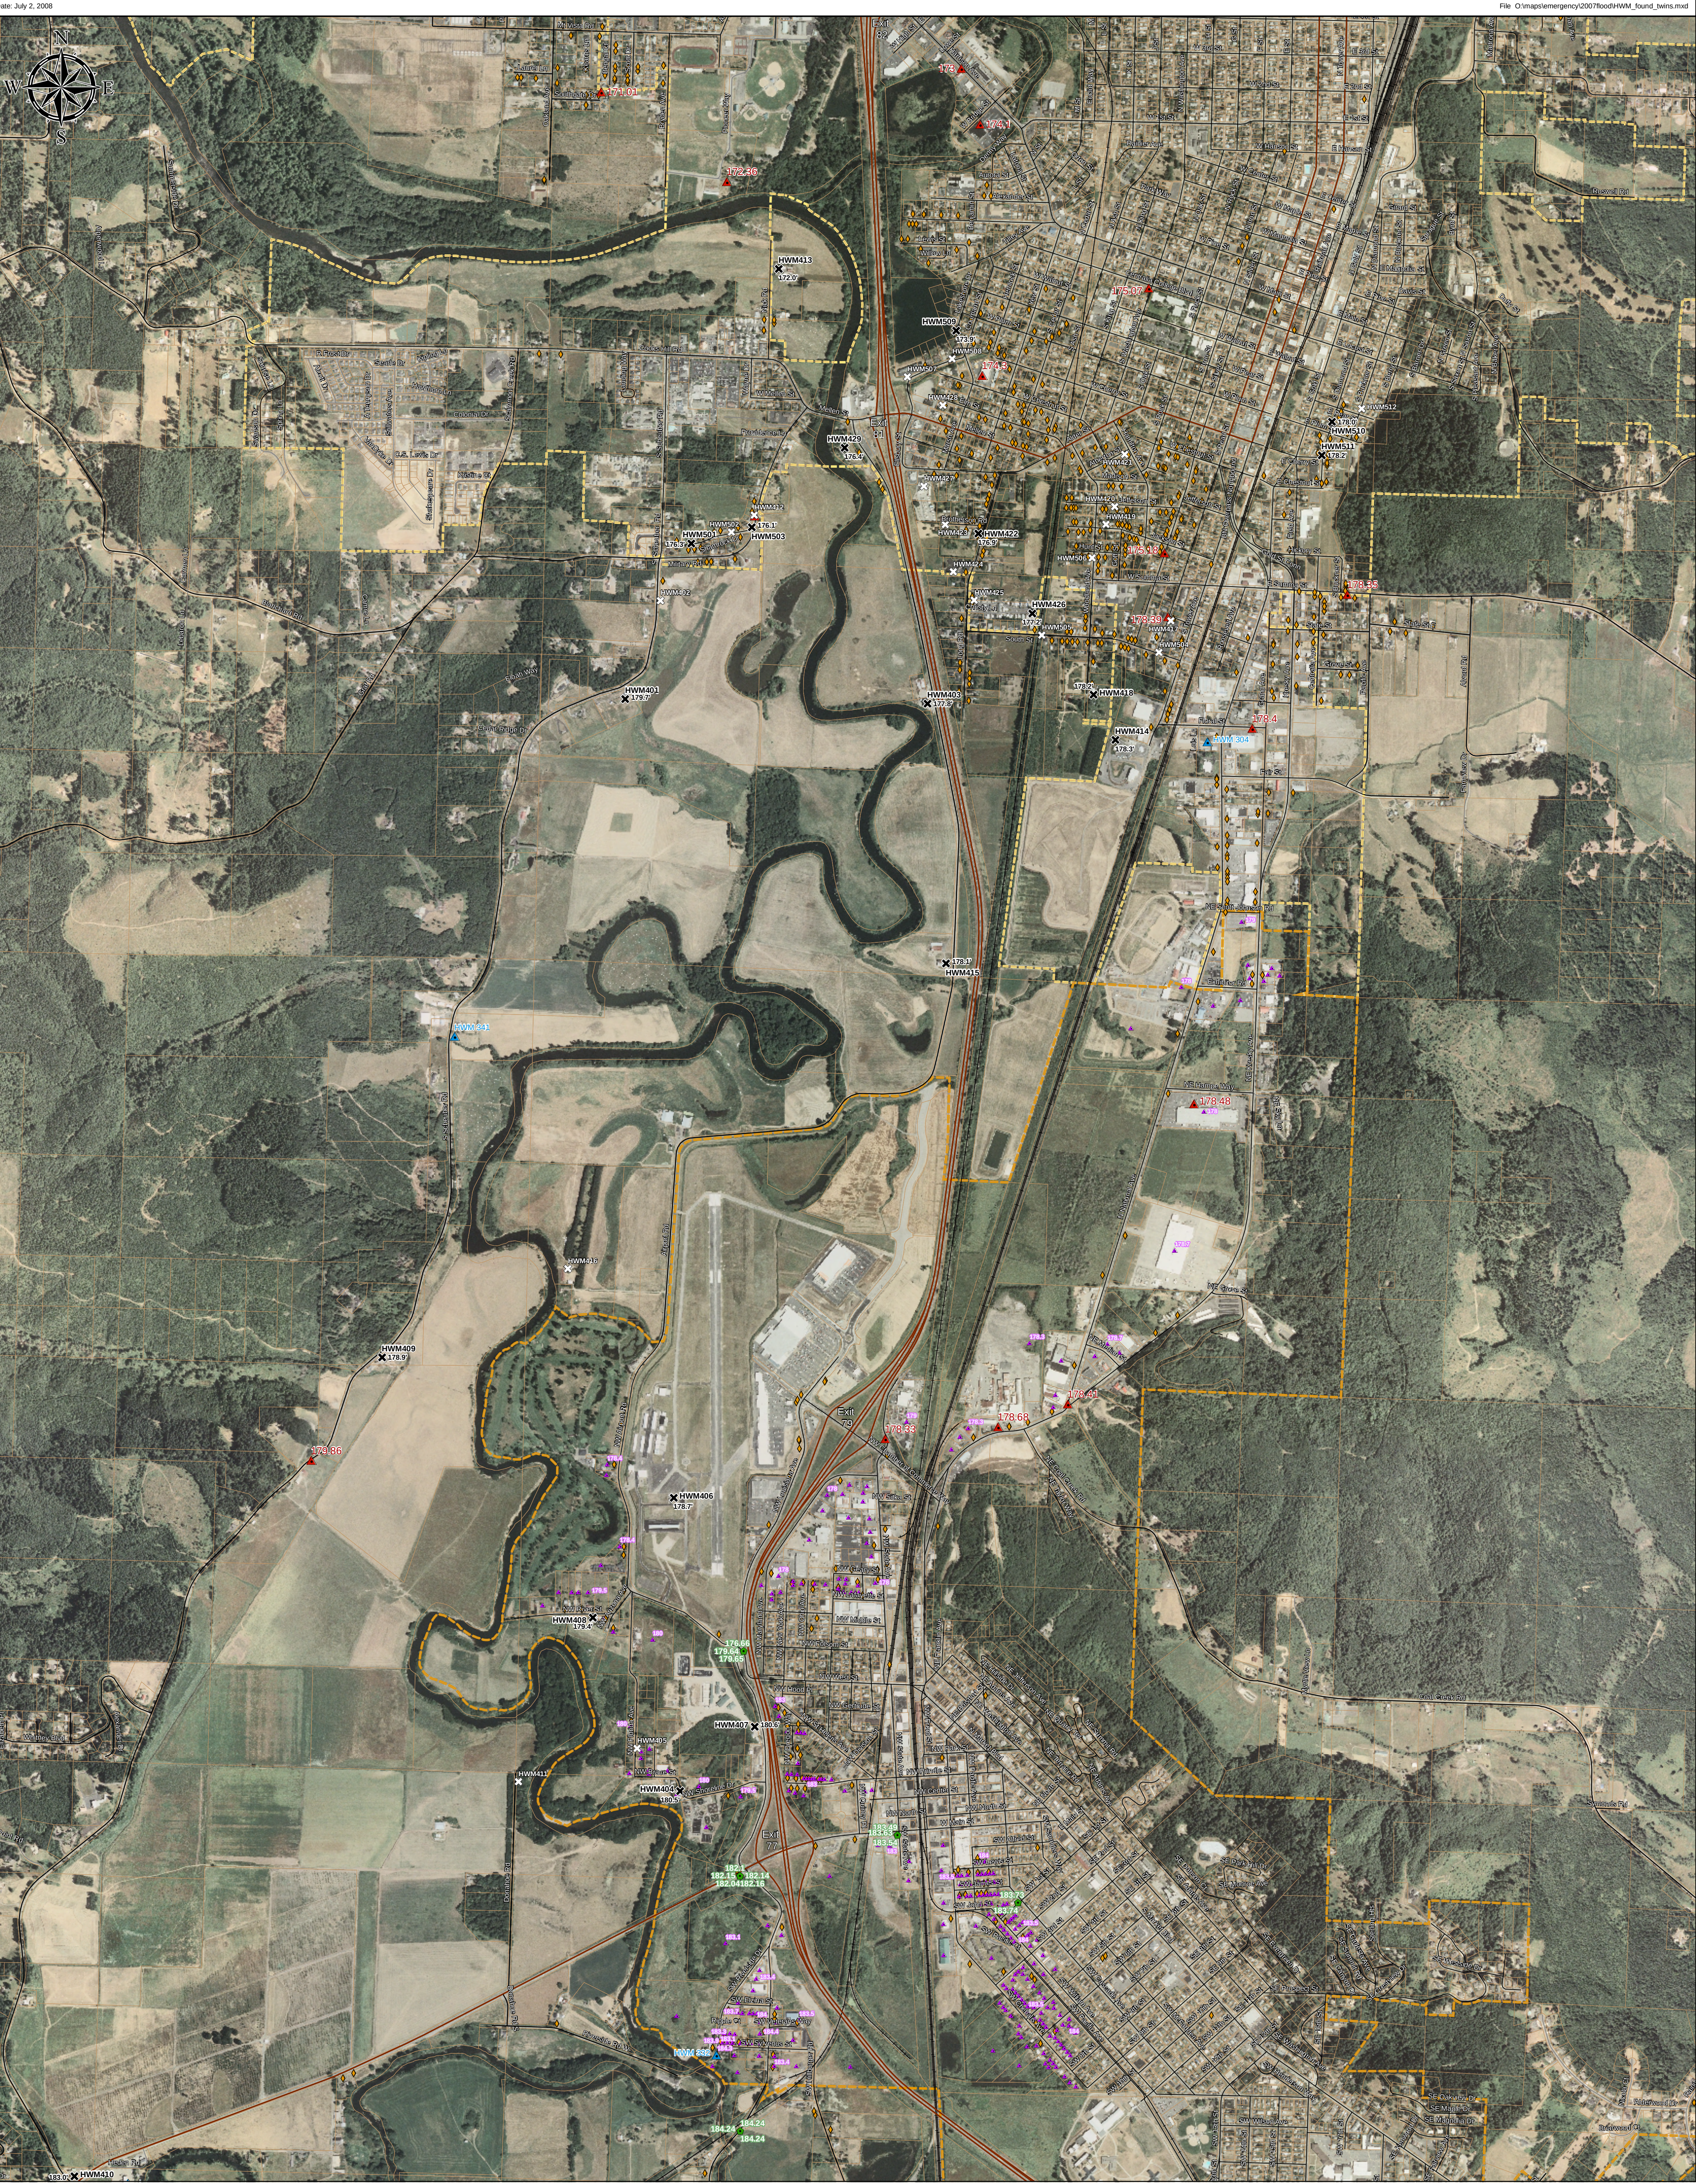
- 2007 Lewis Co HWM elevations captured by RTK GPS.  
- 2007 Chehalis HWM elevations from City of Chehalis structure inventory.  
- 2007 WSDOE HWM elevations captured by RTK GPS  
- 2007 Damage locations from Lewis Co DEM preliminary reports, geocoded by address.  
- Aerial photo taken in 2006.

All elevations displayed in NGVD29 vertical datum.  
Coordinate System: Wa State Plane S Zone NAD83  
Scale: 1" = 950'
